Audit report for the EMEP station

Vavihill, Sweden

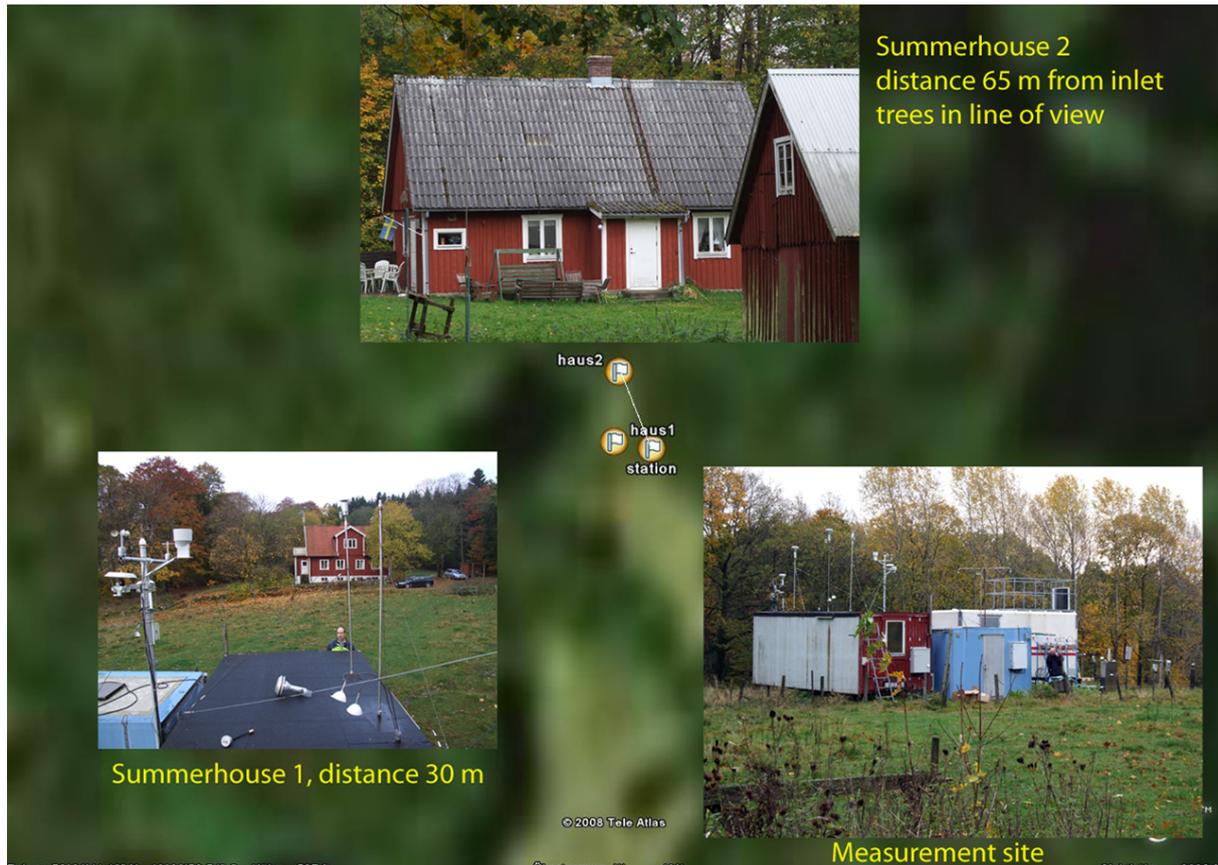
Two summerhouses are located close to the site (Figure 1). Both houses do have chimneys and barbecue sites next to them which are possible intermittent source of local pollution. A NO_x monitor was supposed to be installed at the site to identify local pollution but was not yet available in October 2008. Measurement data from approximately 270° to 360° may therefore need to be excluded from the existing data set.

Figure 1: Vavihill monitoring site with nearby possible local sources. Indicated distances obtained from GPS data.

Solving the problem of the nearby local sources will be more difficult. Currently data from the affected wind sector should be at least flagged unreliable. Relocation of the measurement site may be necessary in the future to ensure reliable data quality for (not so uncommon) winds from West to North.

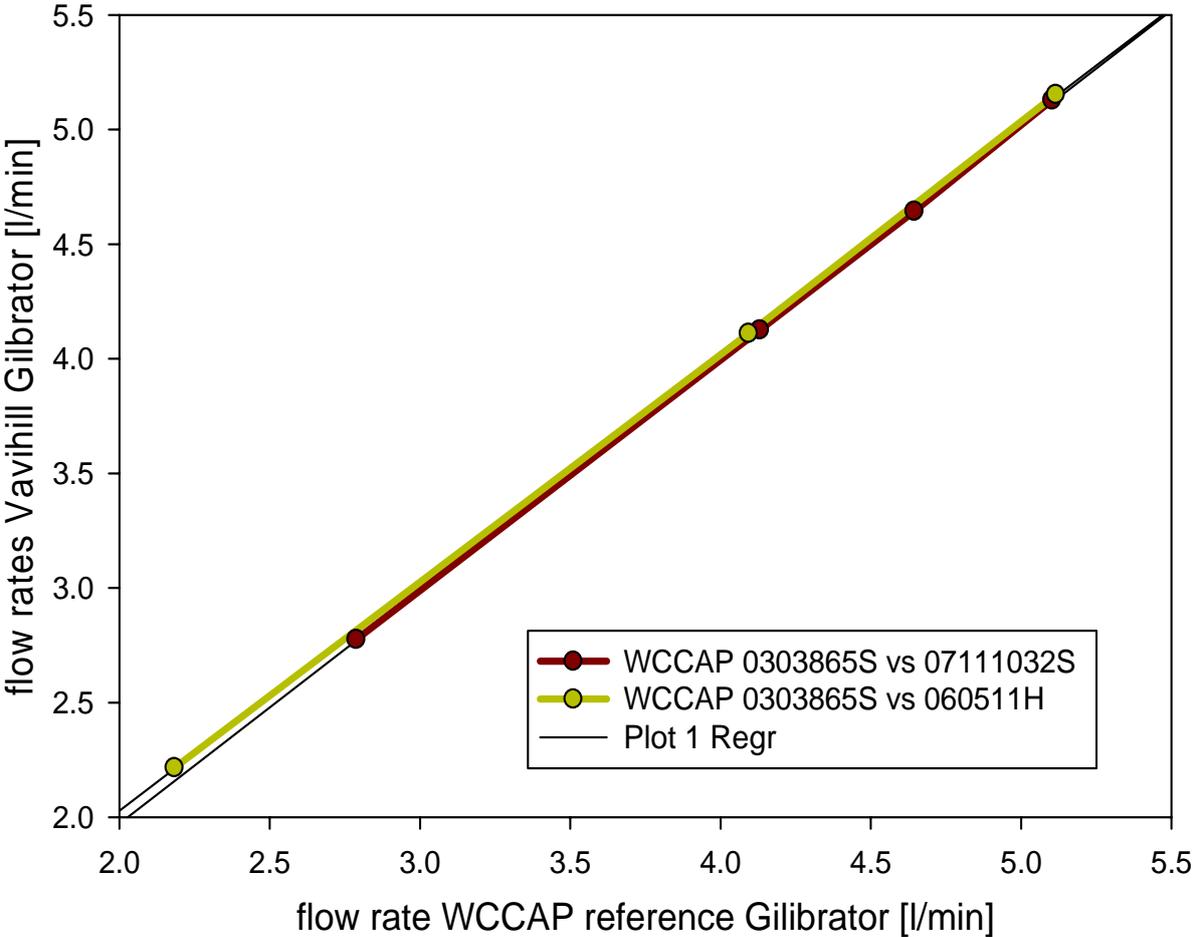
Figure 3: Comparison of flow standards at Vavihill with WCCAP standard.

A Gilibrator is available as primary flow standard at the site. Both flow cells have been verified against the WCCAP reference during this audit. (figure 3). Note that WCCAP values have been corrected for the known deviation of this cell (-1.5%). The average deviation of the high flow cell was found to be + 0.9 % whereas the deviation of the small cell was less than -0.1%

The primary flow standards comply with EUSAAR requirements

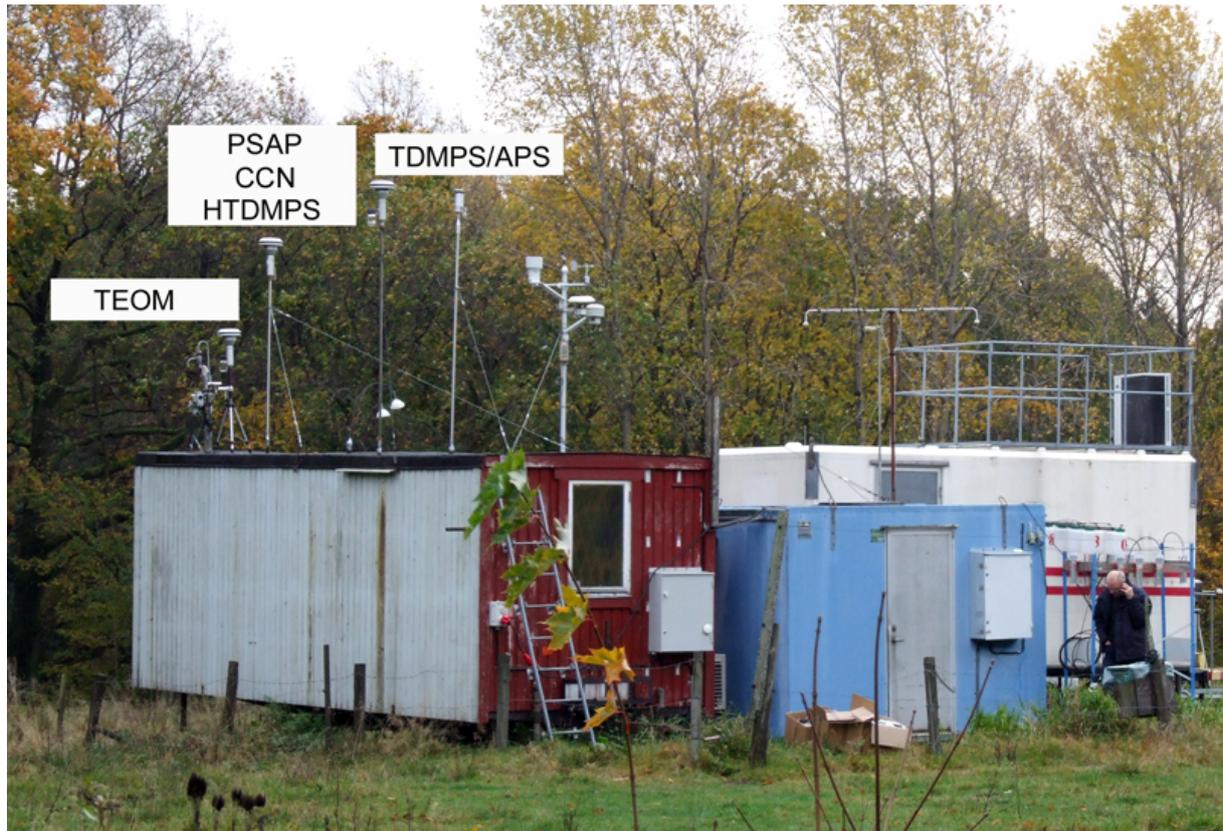
Figure 3: Aerosol inlets at Vavihill.

Three separate aerosol inlets with commercially available PM10 sampling heads are used at Vavihill (figure 3). There was no adapter available during our audit to check inlet flow rates with a primary flow standard. The missing adaptor is probably the reason for the missing flow checks of the TEOM addressed later in this report.

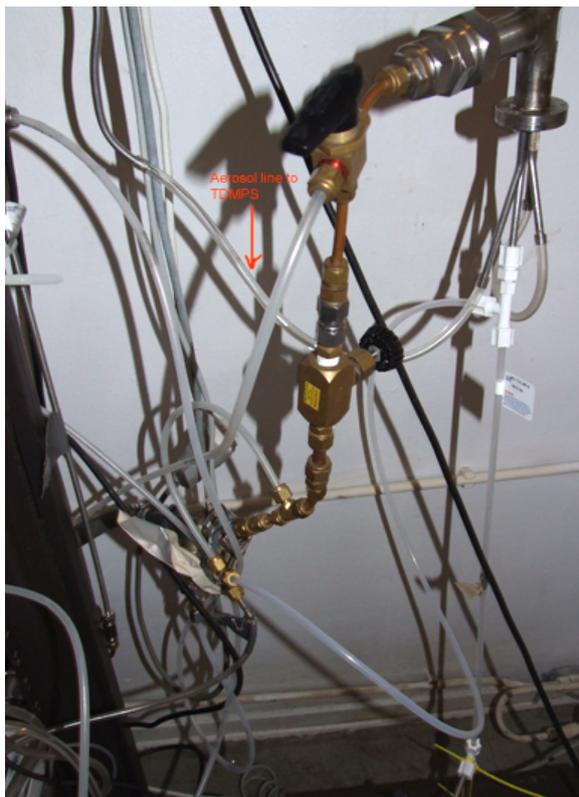
Figure 4: Inlet TDMPS/APS

The first inlet from the right is used for the TDMPS system and the APS. The flow splitter for this system is shown in figure 4. Note that the major flow of this flow splitter (~ 13 l/min) is drawn perpendicular to the aerosol sample flows. This design may act as a virtual impactor influencing measured size distributions. A plastic nafion dryer is used for humidity conditioning of the APS sample whereas a stainless steel nafion dryer is used for the TDMPS. Note that the sample line to the TDMPS was made of Tygon tubing which may cause losses of ultrafine particles. This tubing has been replaced by TSI black conducting tubing during the audit.

After replacement of Tygon tubing by stainless steel or conductive black tubing aerosol inlets at Vavihill comply with EUSAAR standards. Possible effects of the flow splitters on the size distribution need to be investigated.

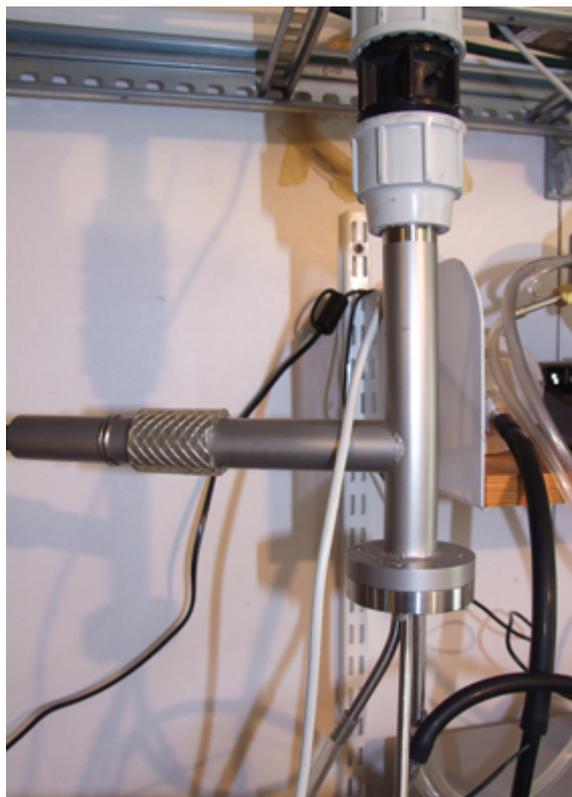
The inlet used for the HTDMA, CCNC and the PSAP is shown in figure 5. Its design is similar to the TDMPS inlet. Tygon tubing is again used as sampling line to the PSAP. Note that all aerosol lines in an inlet or in an instrument should be made of stainless steel or conductive black tubing to avoid particle losses due to image forces.

Figure 5: Inlet CCNC/PSAP/HTDMA

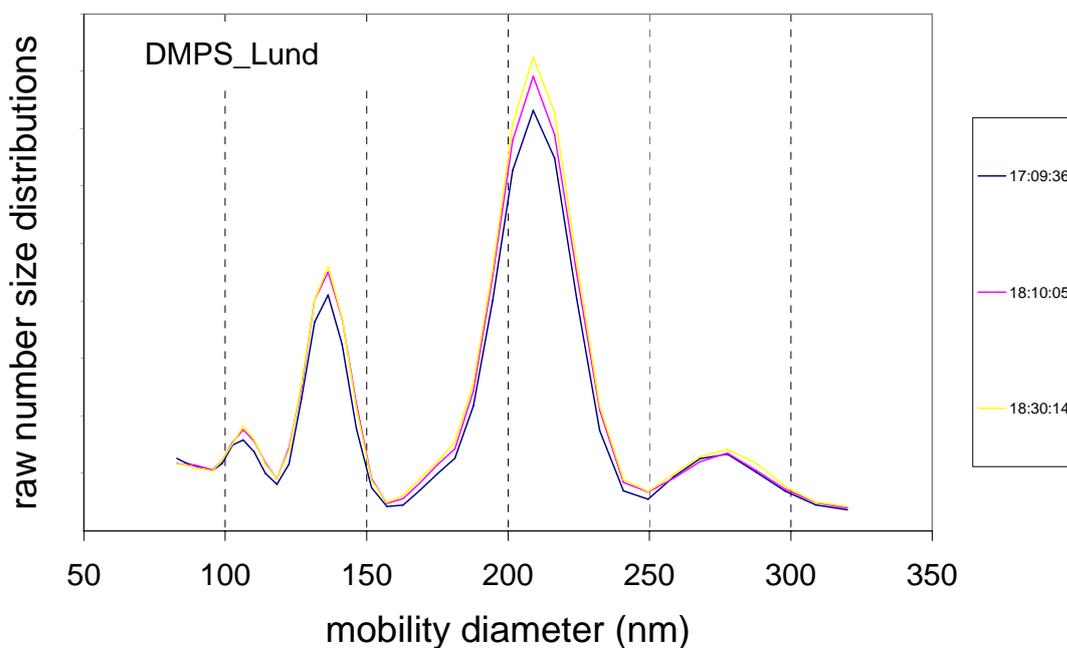
Figure 7: Raw number size distribution of 200 nm Latex measured with Vavihill system during the Intercomparison workshop in Leipzig 2006 (Nowack).

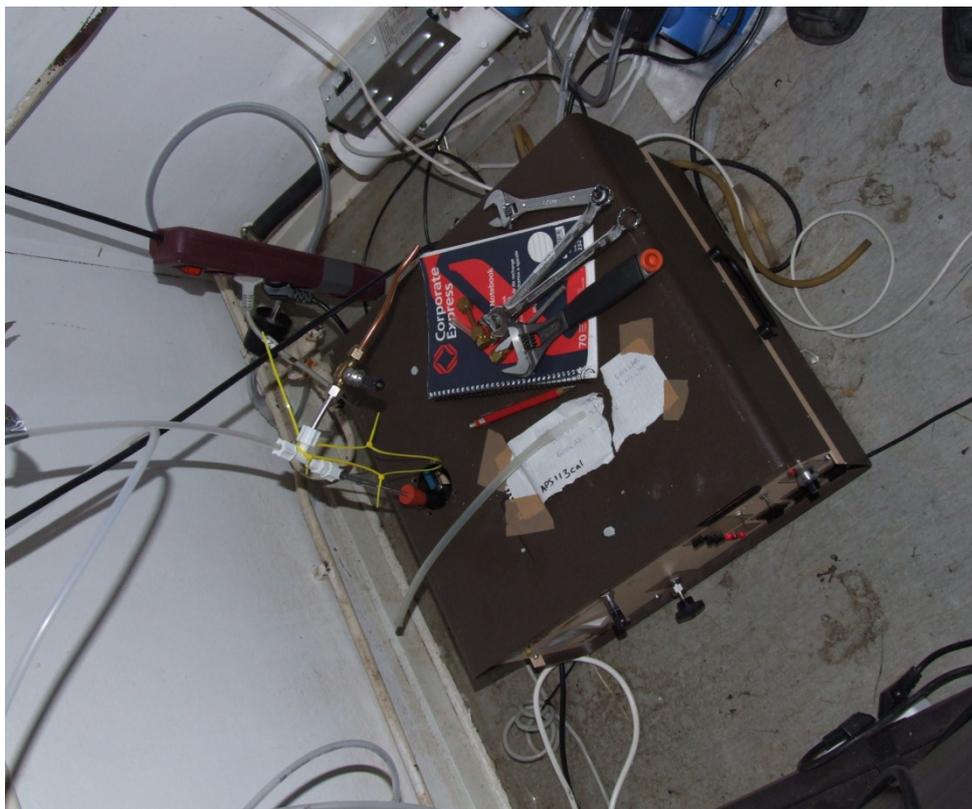
Figure 8: APS at Vavihill.

The APS was standing on the floor and did not appear to be well maintained (figure 8). The inlet of the APS was leaking (figure 10).

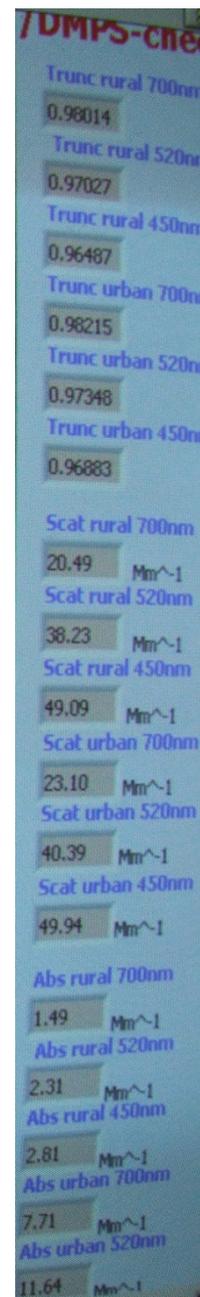
Figure 9: Automatic Mie Calculation.

An interesting feature of the system is the automatic MIE calculation for rural and urban aerosol types allowing comparison of model results from TDMPs measurements with actual measured scattering and absorption coefficients (figure 9). This feature is used for onsite quality control.

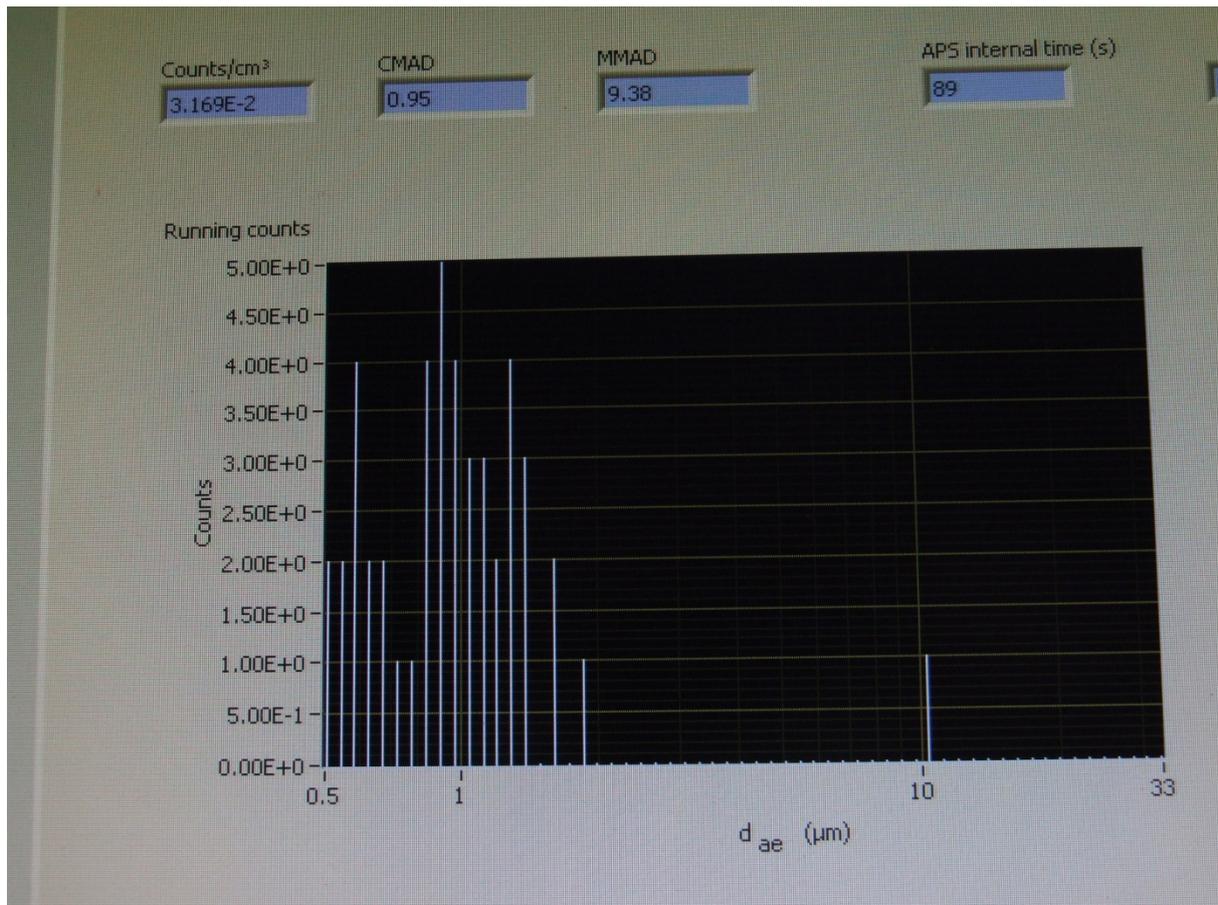
Figure 10: Counts of the APS with an absolute filter.

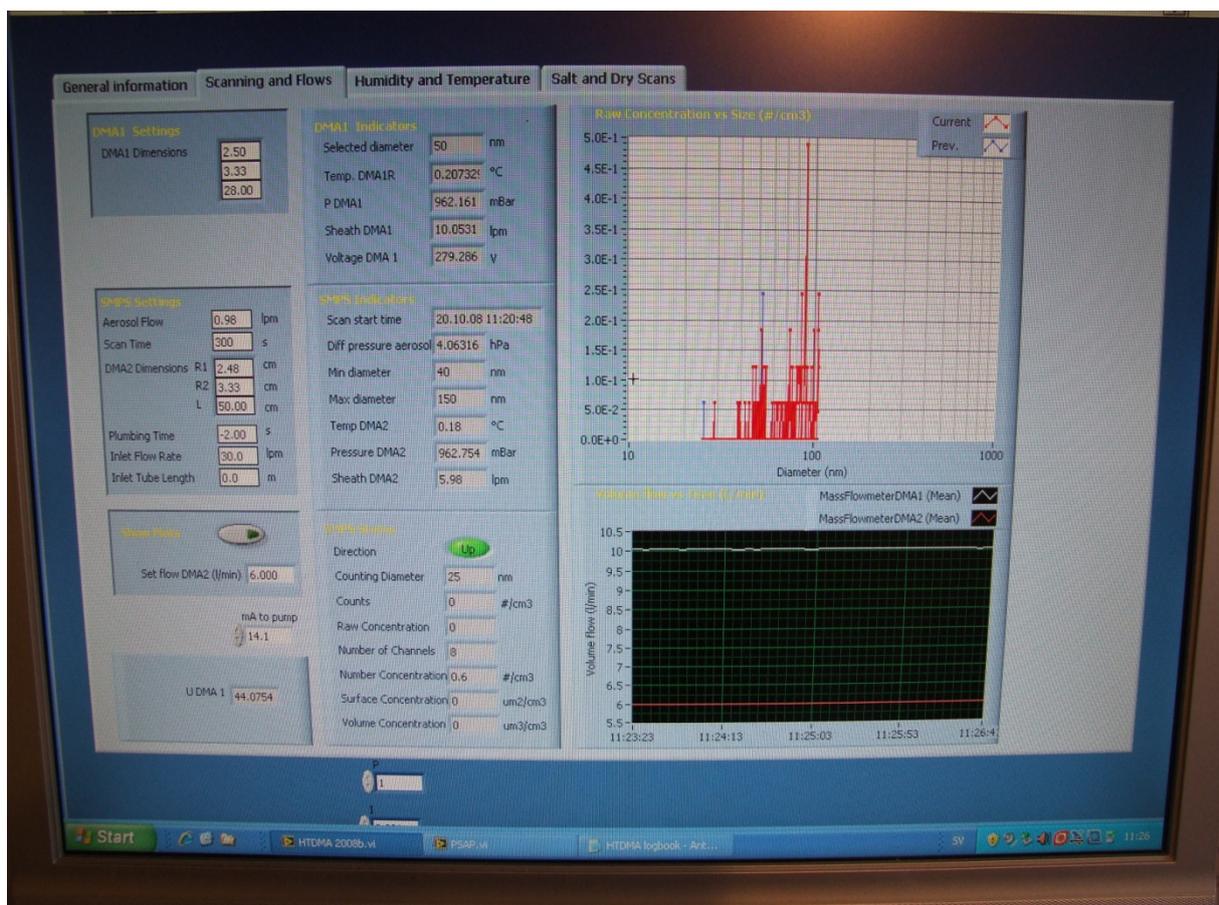
During the audit the HTDMA was obviously leaking with an absolute filter in front of the system. (figure 11).

Figure 11: HTDMA measurement with an absolute filter

If the leak in the system can be fixed the HTDMA at Vavihill will be in good working condition.

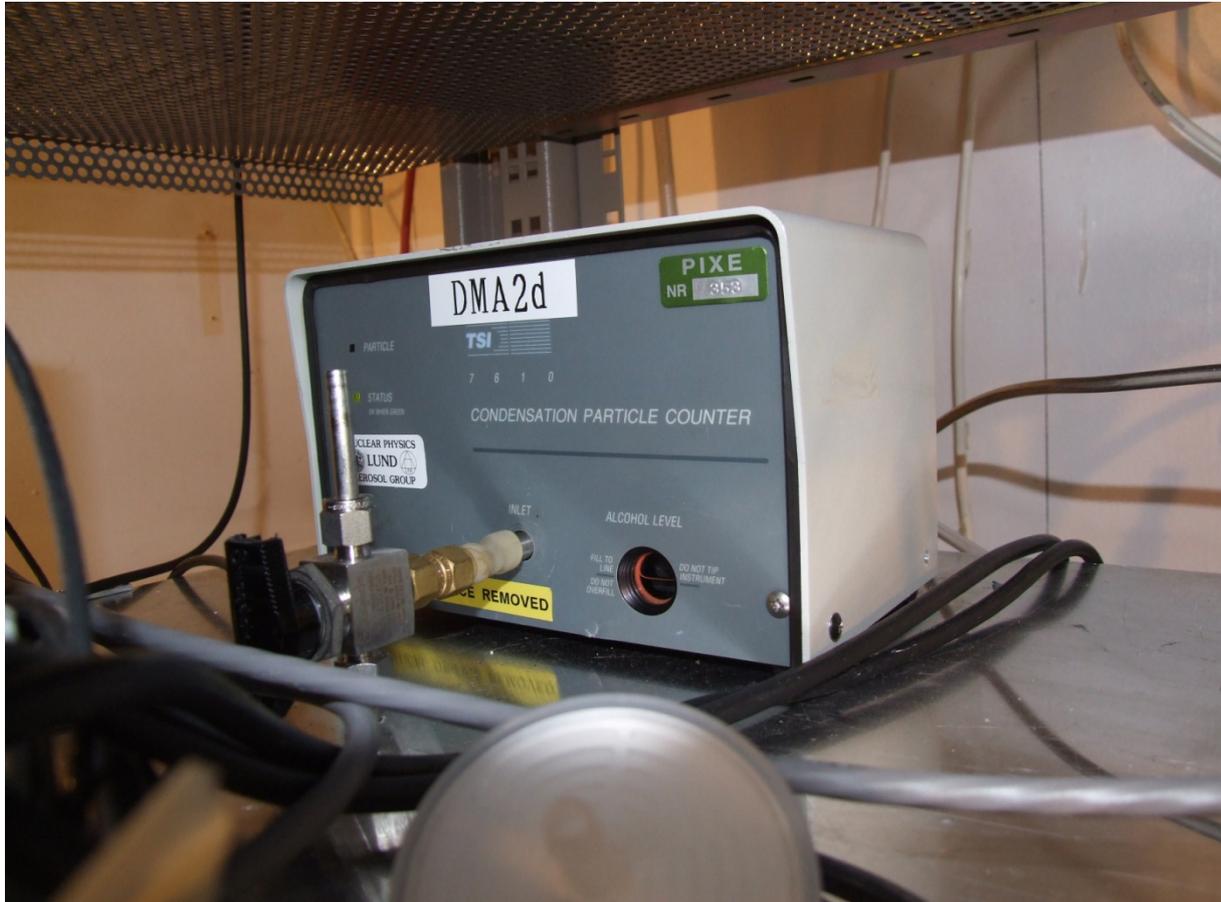
A flow difference of 40 ml between inlet and CPC indicated presence of a leak which may have been caused by different reasons like bad connections as shown in figure 12.

Figure 12: Connection of a CPC in the HTDMA
