Audit report for the EMEP station

Vavihill, Sweden

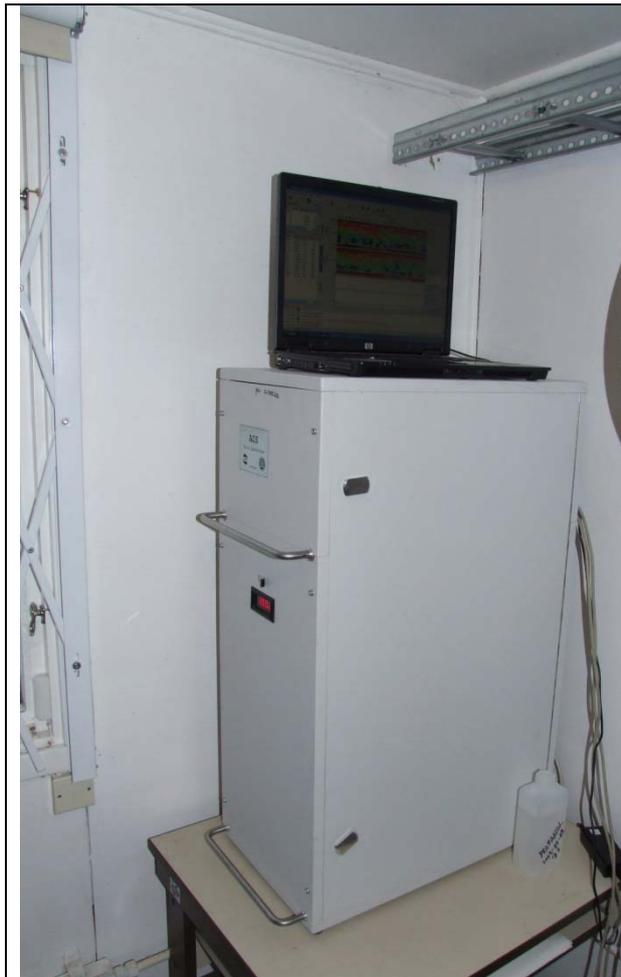
Figure 13: AIS

An air ion spectrometer is available at the site. (figure 13 AIS and figure 14 inlet). Currently there are no audit procedures available for this instrument.

The AIS was not audited.
